## LIFETIME EVALUATION OF A STEAM PIPELINE USING NDE METHODS

**Fevzi Kafexhiu, Jelena Vojvodič Tuma**

Before its shutdown, the steam pipeline made from X20CrMoV121 steel in the Power Plant Toplarna – Ljubljana operated at 530 °C and 95 bar for 150 000 h. A non-destructive evaluation (NDE) of the microstructure using the replica method and hardness measurements on pipeline bends and welded joints with the aim to evaluate for possible damage due to creep deformation was applied. The hardness of the different zones of the welded joints, base material, heat-affected zone and the weld material itself was appropriate and corresponded to the tensile strength in the range required by the standards. A martensitic appearance in all the observed locations was noticeable. Micro-voids that arise due to creep deformation along the former austenite grain boundaries and along the martensite lamellas on the inspected sites were not observed. According to the VGB<sup>1</sup> classification, the steel corresponds to the 2b class.

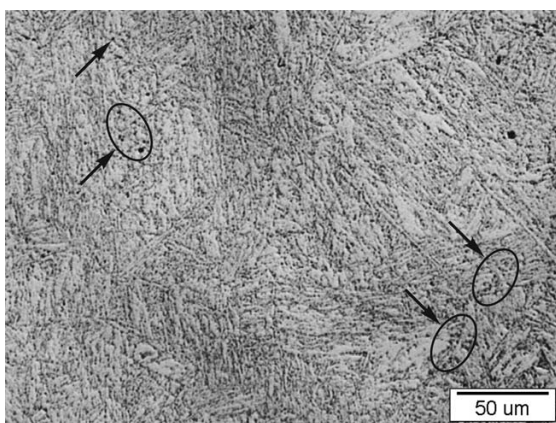
The microstructure on the outer side of the bends is a highly tempered martensite. A martensitic appearance in all the investigated locations is noticeable. We observed a few regions with numerous cavities or micro-voids without preferred orientation, which arose due to the creep deformation. The microstructural features are the same in all the observed locations (**Figures 2 and 3**).

**Figure 2:** Microstructure of steel in the bend 1  
**Slika 2:** Mikrostruktura jekla na kolenu 1

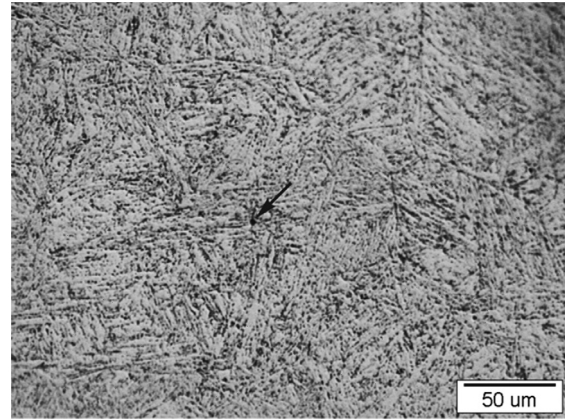
**Figure 3:** Microstructure of steel in the bend 5  
**Slika 3:** Mikrostruktura jekla na kolenu 5

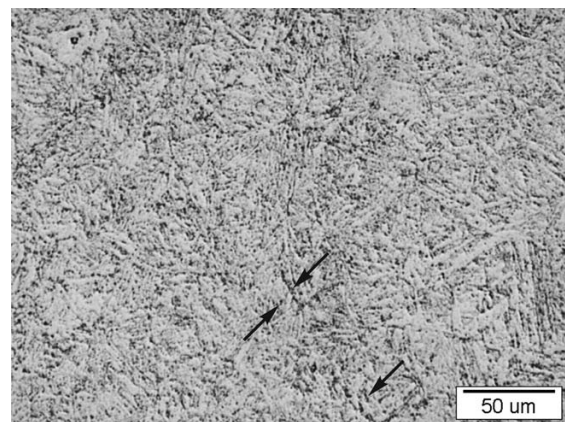
microstructure of the welds is also a tempered martensite; however, it was observed that the size of the former austenite grains was larger compared to those of the base material. Because of welding effects, the tempered martensite microstructure in the transition region between the weld and the heat-affected zone is strongly blurred. In the heat-affected zone and in the weld material, which are loaded with internal steam pressure, stresses due to the welding and with additional static and dynamic loads during the operation (temperature fluctuations, bending moments, vibrations, etc.), we also observed a few micro-voids. The microstructural features of the welded joints are shown in **Figures 4, 5 and 6**.

**Figure 4:** Microstructure of the base material in the welded joint of the bend 1  
**Slika 4:** Mikrostruktura osnovnega materiala ob zvaru na kolenu 1

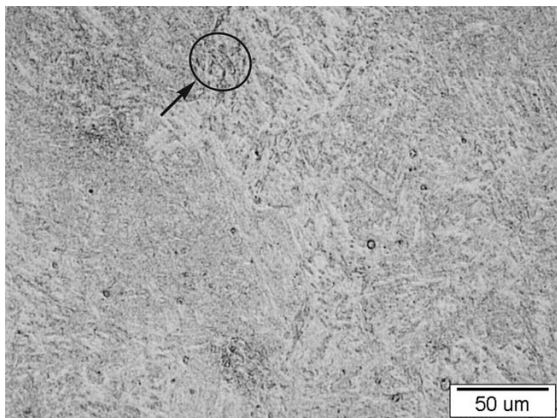
**Figure 5:** Microstructure of the weld in the welded joint of bend 1  
**Slika 5:** Mikrostruktura vara ob zvaru na kolenu 1

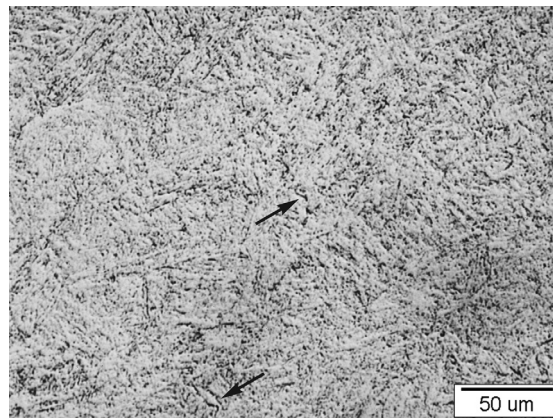
The microstructural characteristics in the base material and in the welded joints of the T-fitting are the same as in the pipelines (**Figures 7, 8 and 9**). The base material has an appropriate microstructure of tempered martensite. In the microstructure of tempered martensite of the weld and the heat-affected zone there are a few regions with micro-voids, which as in the case of bends, have no preferred orientation.

**Figure 8:** Microstructure of the weld in the welded joint of the T-fitting  
**Slika 8:** Mikrostruktura vara ob zvaru na T-kosu

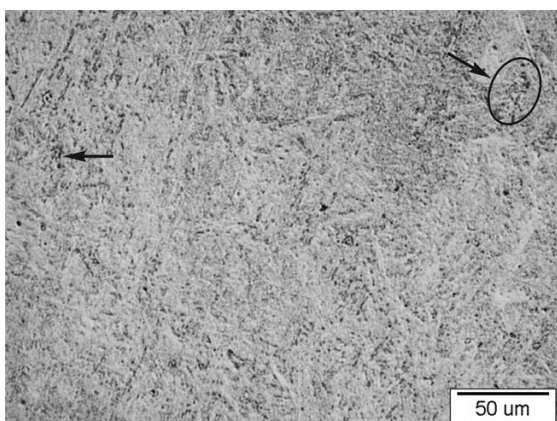
**Figure 6:** Microstructure of the HAZ in the welded joint of bend 1  
**Slika 6:** Mikrostruktura TVP ob zvaru na kolenu 1

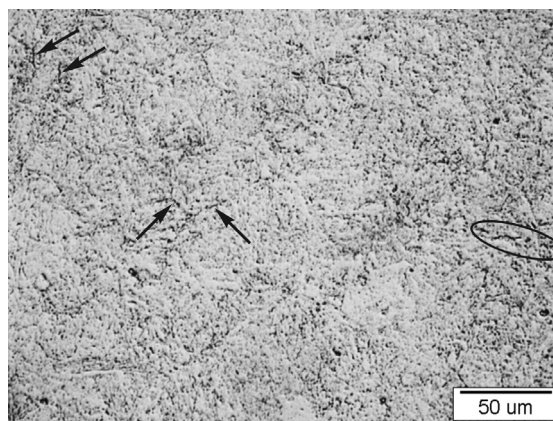
**Figure 9:** Microstructure of the HAZ in the welded joint of the T-fitting  
**Slika 9:** Mikrostruktura TVP ob zvaru na T-kosu

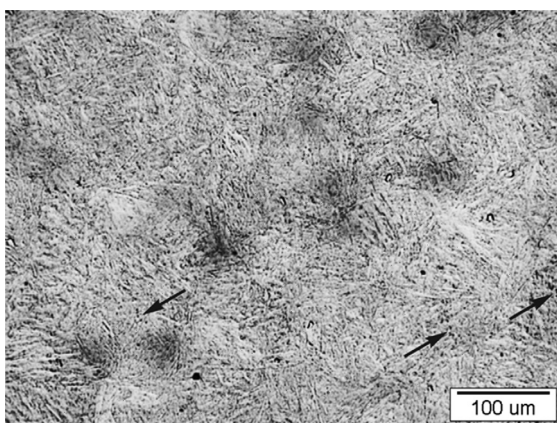
**Figure 7:** Microstructure of the base material in the welded joint of the T-fitting  
**Slika 7:** Mikrostruktura osnovnega materiala ob zvaru na T-kosu
