# INVESTIGATION OF PIPELINE FAILURE IN A THERMAL POWER PLANT'S PROCESS WASTEWATER DISTRIBUTION SYSTEM

<sup>1</sup>HEP Proizvodnja d.o.o. TE Plomin, Plomin luka 50, 52234 Plomin, Croatia

In this paper, abundant, compacted, dust-like, corrosion scales from the interior of a corrosion-damaged pipeline were analyzed to determine the main reason for leakage and flow damping in the process-wastewater distribution system in the thermal power plant Plomin. The chemical composition, morphology and microbiological activity of the corrosion deposits present on the inner pipe wall were investigated and the physical and chemical analyses of the purified boiler water was made. The results show the presence of iron-related bacteria (IRB) in the corrosion deposits as well as in the distribution system water. XRD analysis shows exclusively magnetite and goethite with no calcium carbonate present in the layers, therefore indicating that no protective carbonate scales, which would protect the pipeline steel, had initially formed. It was concluded that the primary causes of intense corrosion were iron-oxidizing bacteria, that through their metabolism, support the redox cycling process, the formation

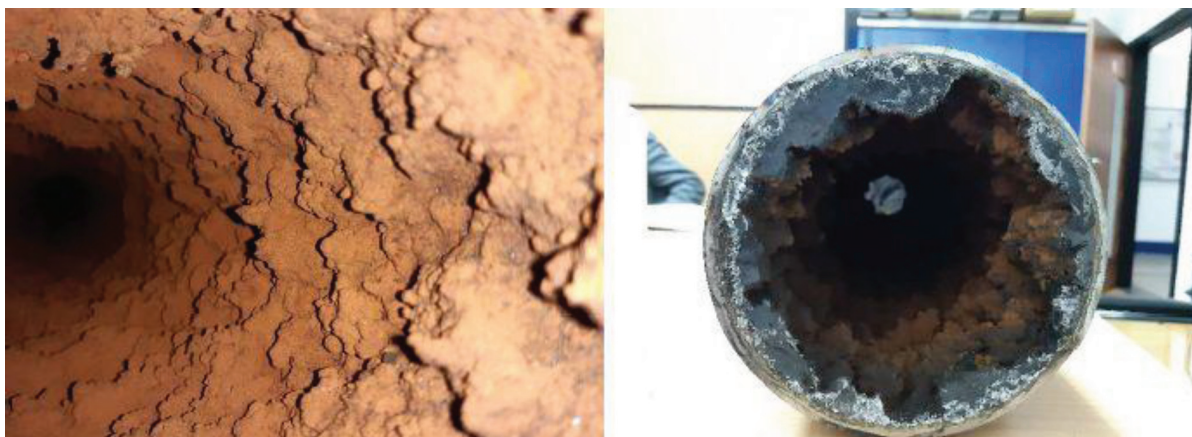
**Figure 1:** Appearance of the interior of the investigated steel pressure pipeline

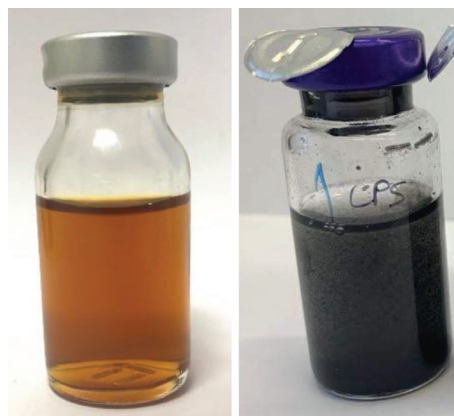
**Figure 2:** Control results of: a) IRB-bearing and b) SRB-bearing samples

The control results of IRB and SRB-bearing samples are shown in **Figures 2a** and **2b**, respectively. The wastewater and corrosion sediments tests yielded identical results shown in **Figures 3a** and **3b**. Positive results were obtained for IRB and negative for SRB.

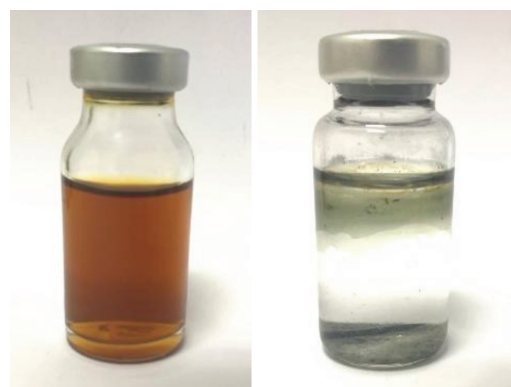
**Figure 3:** Results of positive IRB test and negative SRB test, obtained in both wastewater and corrosion product samples

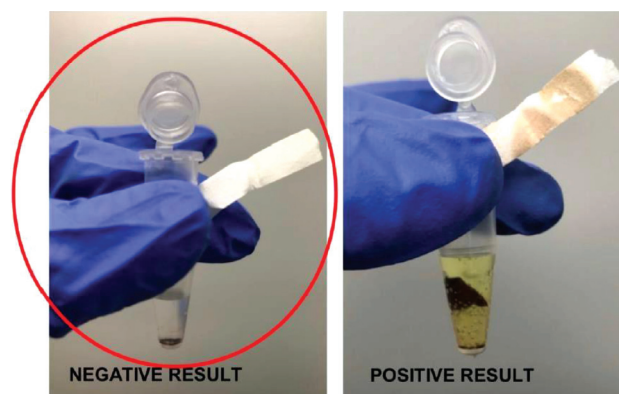
The control results of the sulfide analysis for the sulfide-free and sulfide-bearing samples are shown in **Figures 4a** and **4b**, respectively. These were used for a visual assessment of the tested samples.

**Figure 4:** Control results of a lead acetate paper test on a sulfide-free and a sulfide-bearing sample

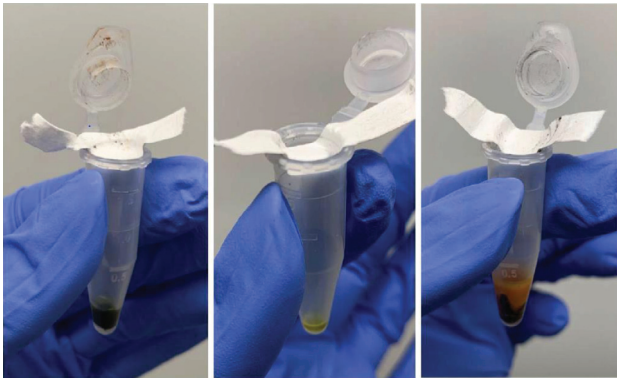
The results of the sulfide analysis on the central, bottom and top layers of the sediment are shown in **Figure 5**.

Comparison with control samples shows that all three samples were negative, i.e., sulphide-free. Since sulphides are formed as a result of SRB metabolism,<sup>17</sup> this result confirms the previous observation that SRB

**Figure 5:** Results of three sulphate test made on central, bottom and top layers of the pipeline wall sediment

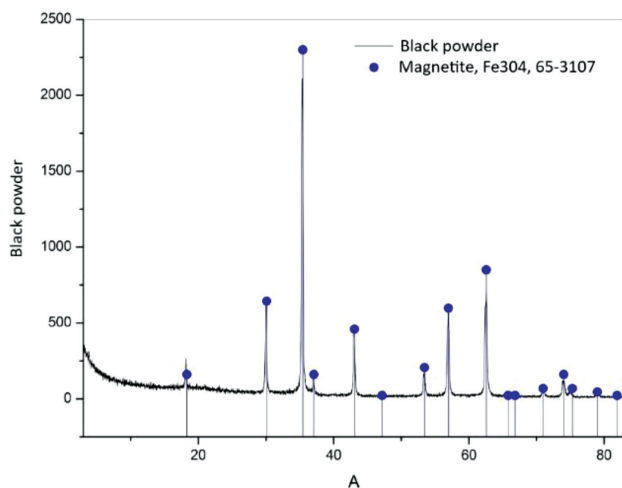
The black sediment sample consists of very well crystallized magnetite,  $\text{Fe}_3\text{O}_4$ , ICDD PDF (International Center for Diffraction of the Powder Diffraction File) # 65-3107. No additional diffraction maxima are observed on the diffractogram, thus it can be determined that magnetite is the only crystalline phase in the sample. Moreover, no amorphous halo is observed, so it can be determined that there is no amorphous phase in a larger share.

**Figure 6:** XRD analysis of black powder residue

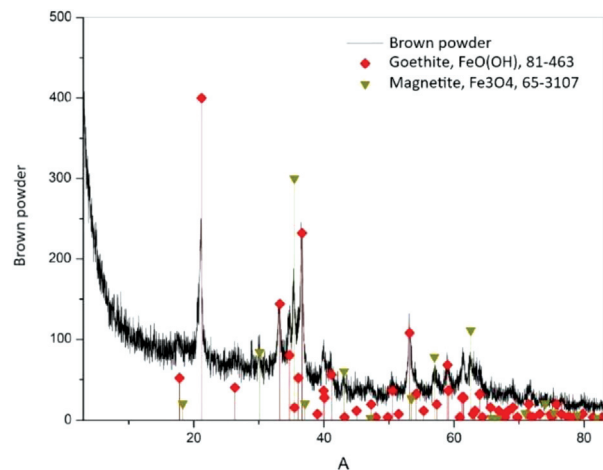
The diffraction maxima of the brown sediment sample are significantly lower and wider, indicating finer crystallites. No pronounced amorphous halo is observed, although the visual impression may be the opposite due to the low intensities. In this sample, the main crystalline phase is goethite,  $\text{FeO}(\text{OH})$ , ICDD PDF # 81-463, while

**Figure 7:** XRD analysis of brown powder residue

the secondary phase is magnetite,  $\text{Fe}_3\text{O}_4$ , ICDD PDF # 65-3107. It is not excluded that another crystalline phase is present in a very small proportion in the sample.

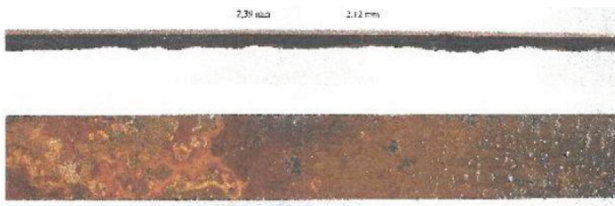
A section of the pressure steel pipeline was cut out, freed from loose corrosion products, ground along the profile, to make a macroscopic sample adequate for inspection of the steel pipe thickness, as seen in **Figure 8**.

Through a visual inspection it was concluded that the surface was extremely damaged and irregularly thinned. Since the entire surface is equally damaged by corrosion, more and more leaks can be expected to occur on the pipeline over time.

**Figure 8:** Marco cut of the damaged pipe wall after removal of loose corrosion products

- The macro sanding of the cut pipe wall revealed that the entire pipe surface, longitudinally and circumferentially, was equally damaged by corrosion, showing irregularities in the form of overlapping wide pits so that over time, more and more leaks can be expected on the pipeline.

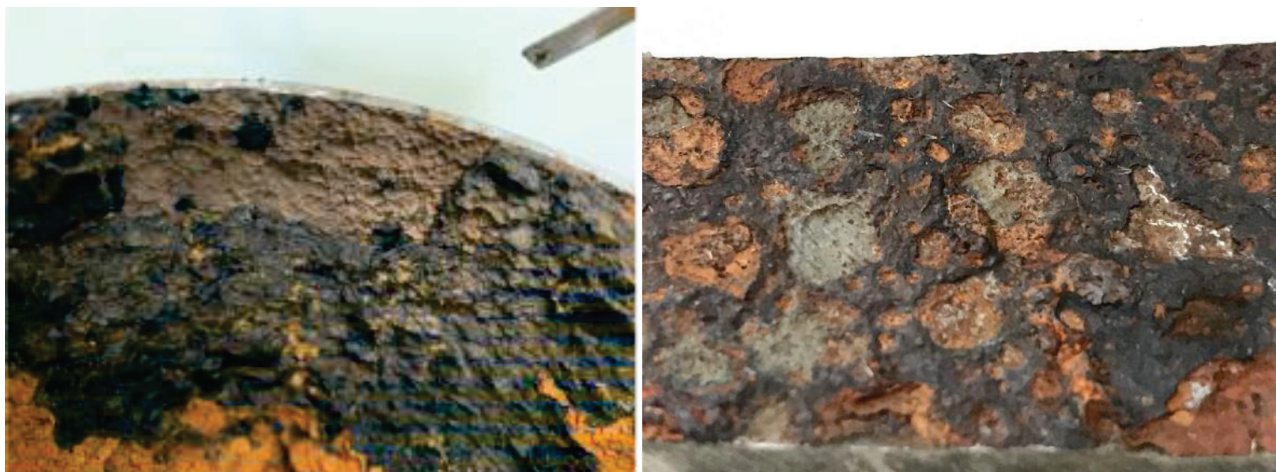
**Figure 9** shows the inner surface of the pipeline after removal of loose corrosion products. Distinctive, anodic (depressed) and cathodic areas are clearly visible at the surface.

**Figure 9:** Inner surface of the pipe wall after removal of loose corrosion products
