INFLUENCE OF PROCESS PARAMETERS ON THE CORROSION RESISTANCE OF CORRUGATED AUSTENITIC AND DUPLEX STAINLESS STEELS

Sandra M. Alvarez, Asunción Bautista, Francisco Velasco

Universidad Carlos III de Madrid, Materials Sci. and Eng. Dept – IAAB, Avda. Universidad 30, Leganés, Madrid, Spain
asuncion.bautista@uc3m.es

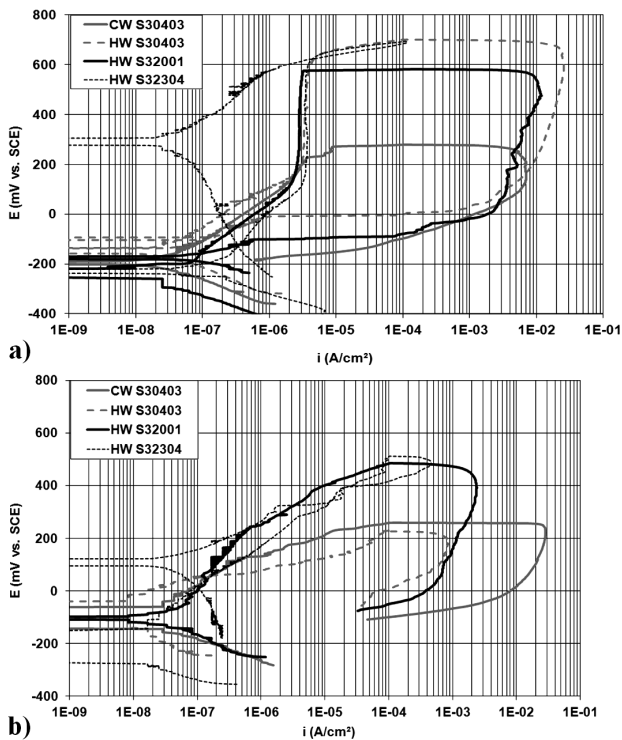
Figure 1: Polarization curves in non-carbonated $\text{Ca}(\text{OH})_2$ solutions with 5 % NaCl: a) centres of the bars, b) corrugated surfaces

The polarization curves of the corrugated surfaces and the centres of the stainless-steel bars clearly exhibit different shapes, as can be seen in **Figure 1**, where the curves corresponding to the non-carbonated solutions with 5 % NaCl are shown. For the samples without corrugations (**Figure 1a**), the pitting potential (E_{pit}) is well defined and corresponds with very sharp current increases. On the other hand, in the tests carried out on the real surfaces of the bars (**Figure 1b**), the current increase after E_{pit} is less pronounced. It must be pointed out that on certain materials exposed to particular testing conditions, no corrosion occurred during the test. This is the case, for example, of the centre of the HW S32304 bar in a non-carbonated solution with 5 % NaCl (**Figure 1a**), where the current increase does not correspond to any corrosion phenomenon but it is due to the water decomposition through reaction 1:

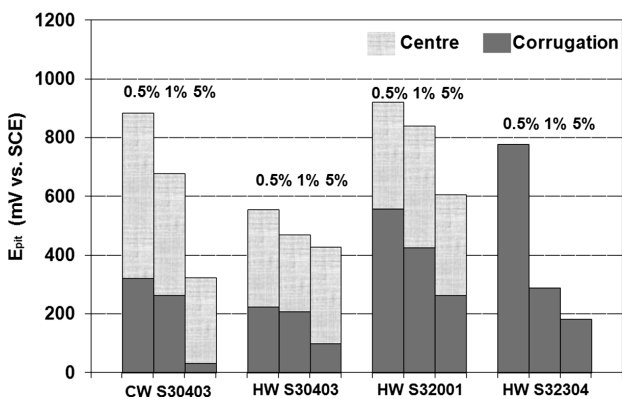
Figure 2: Differences between the E_{pit} measured in the centres of stainless-steel bars and on corrugated surfaces in carbonated $\text{Ca}(\text{OH})_2$ solutions with different chloride contents

It is very interesting to find a significant decrease in the corrosion resistance of the bars due to the changes to the corrugations taking place during the forming process. Figure 2 shows the difference between the E_{pit} values of the studied stainless steels in carbonated solutions, with the measurements carried out on the corrugated surfaces

If the results from **Figures 2** and **3** are used to compare the corrosion behaviours of different grades, it is demonstrated that HW S32304 is clearly more corrosion resistant than any of the studied austenitic grades. Despite the volatility of the prices in the market, it can be considered that a S32304 grade can cost about 9 % less than a S30403 grade. This result justifies the great interest in this DSS grade that is seen as an alternative for the traditional austenitic grade used in these applications, as S32304 has a better performance and it is somewhat more economical. The DSS S32001 grade can be estimated to be about 15 % cheaper than the austenitic S30403. The results of the corrosion tests

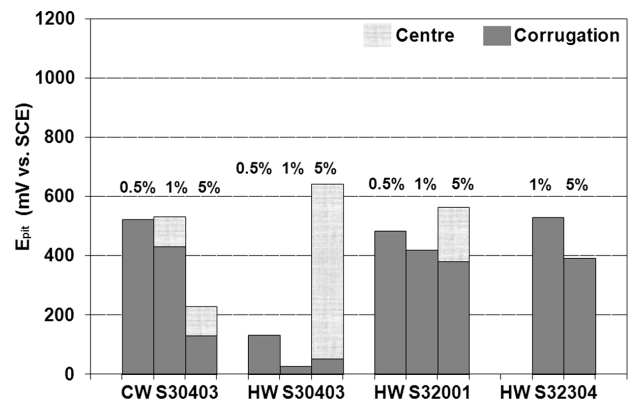
Figure 3: Differences between the E_{pit} measured for the centres of stainless-steel bars and for the corrugated surfaces in non-carbonated $\text{Ca}(\text{OH})_2$ solutions with different chloride contents. Conditions without the plotted E_{pit} values correspond to tests where no corrosion takes place.

In **Figure 3**, the E_{pit} values detected in non-carbonated solutions are plotted. It can be seen that, at a higher pH, it is more difficult to cause corrosion during the test. In the solutions without chlorides, no corrosion occurs in any of the cases and the centre of HW S32304 is immune to the attacks in the testing media with chlorides, as reported for $\text{pH} \approx 9$. Besides, no corrosion occurs during the polarization in the solutions with 0.5 % NaCl on the centres of the other studied bars. In the case of the 1 % NaCl testing solution, no corrosion was found on the centres of HW S30403 or HW S32001.

The corrugated surfaces of the bars prove again to be much more prone to corrosion. For this type of samples, the only condition where no pitting is detected is HW S32304 with 0.5 % NaCl. The important influence of the microstructural changes occurring in the surfaces of the corrugated bars during the forming process is again clearly proved.

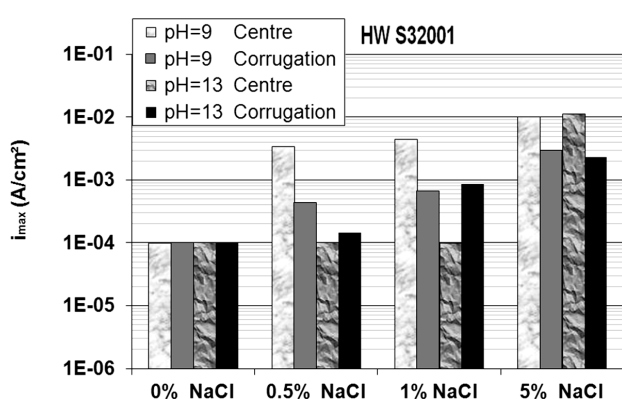
Figure 4: Differences between the i_{max} values obtained with the polarization curves for the centres and the corrugated surfaces of duplex HW S32001 bars in carbonated and non-carbonated $\text{Ca}(\text{OH})_2$ solutions with different chloride contents

In addition to E_{pit} , another interesting parameter, which can be obtained from the polarization curves, is the maximum intensity (i_{max}) reached during the measurements. All the curves are programmed to reverse the potential sweep when a current intensity of 10^{-4} A/cm² is reached. When no corrosion occurs, i_{max} is 10^{-4} A/cm², as the current quickly decreases when the applied potentials decrease. When pits are formed during the anodic polarization, the current still increases as the potentials start to decrease due to the important autocatalytic effect of the localized corrosion. The higher the i_{max} , the more dangerous is the pitting morphology. As an example, the values of this parameter for sixteen tested conditions of HW S32001 were plotted in **Figure 4**. If the conditions, under which no corrosion takes

place, are not considered (0 % NaCl and the centre of the bar for 0.5 and 1 % NaCl at $\text{pH} \approx 13$), it can be seen that the samples from the centre of the bar, though less susceptible to corrosion than the corrugated surfaces, suffer from a more aggressive attack than when it occurs on the surface. The same conclusion is reached if the results for the other four studied materials are analyzed. It can also be seen in **Figure 4** that chlorides have an important influence on the increase of i_{max} .

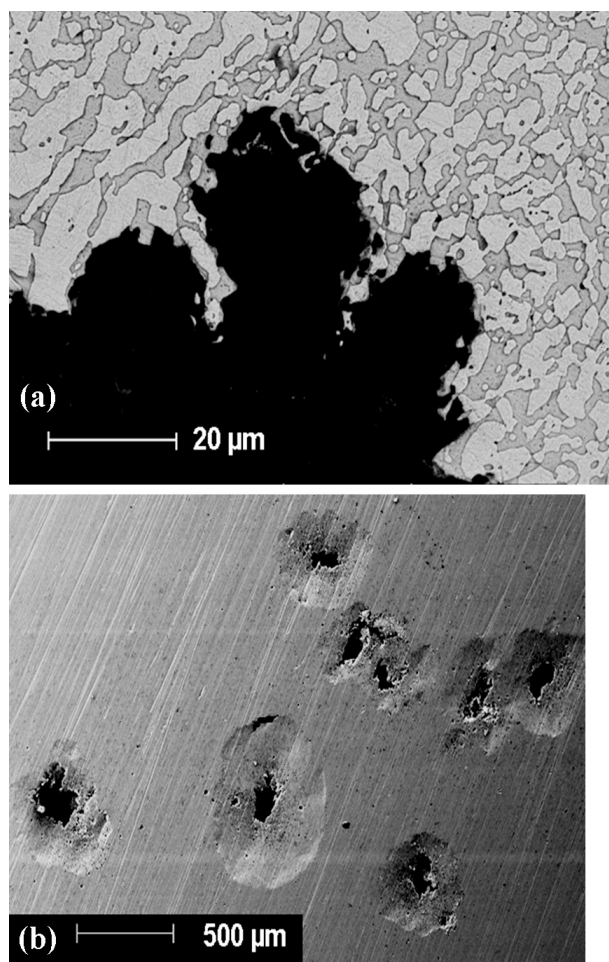
Figure 5: Images of different morphologies of the attacks that appear on the centre of a bar and on the corrugated surface. The pits after the polarization of HW S32001 in non-carbonated $\text{Ca}(\text{OH})_2$ solutions with 5 % NaCl: a) corrugated surface, b) center of the bar.

An observation of the morphology of the pits after the polarization curves confirms the idea deduced from the i_{max} values. As it can be seen in **Figure 5**, the polarization causes small, shallow pits widely distributed on the most deformed regions of the surface of the corrugation. In the centre of the bar, polarizations cause scarce, but much bigger pits that can be much more dangerous.
